**Flood Control Project Maintenance****2013 Structure Summary Report****Overall Unit and Item Ratings****Lower San Joaquin Levee District****Ash Slough Drop Structure No. 1**

Overall Unit Rating	Rated Item	Item Rating
<b>A</b>	Photo Documentation	N
	Vegetation & Obstructions	A
	Shoaling / Sedimentation	A
	Erosion / Bank Caving	A
	Revetments	M
	Encroachments	A
	Culverts: Inlets / Outlets	N
	Culverts: Breaks / Holes / Cracks	N
	Metal Pipes	N
	Trash Racks	N
	Flap Gates	N
	Sluice/Slide Gates	N
	Electric Gate Operators	N
	Manual Gate Operators	N
	Concrete Surfaces	A
	Concrete Tilting / Settlement	A
	Concrete Foundations	A
	Security Fencing	N
	Closure Structures	N
	Trash Rakes	N
	Other Metallic Items	N
	Monolith Joints	A
	Safety	A
	Operation & Maintenance Manual	A

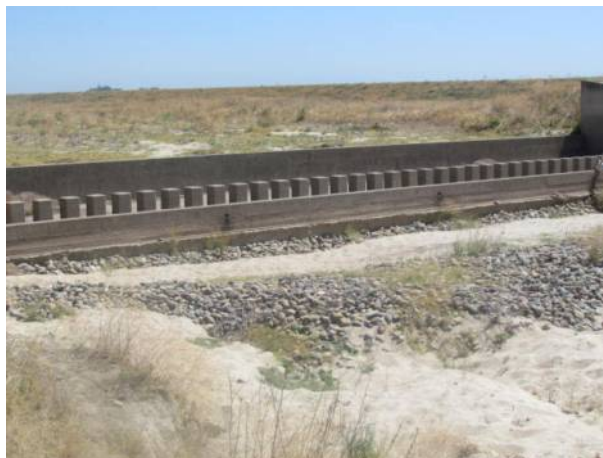
richard\_t\_20130715\_002.JPG

Looking northeast at downstream side of structure riprap displacement.

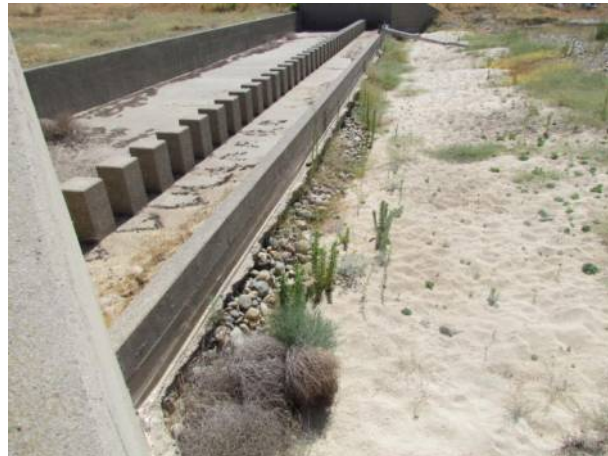
Levee Mile Report Line	5
Start Levee Mile	0.00
End Levee Mile	0.00
Location	
Category	Structures
Item	Revetments
Looking east at riprap displacement on downstream side of structure. (2013)	
Richard_t_20130730_142.JPG

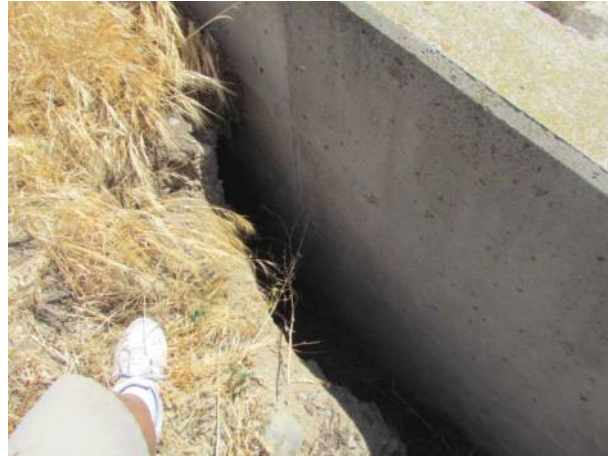
Richard\_t\_20130730\_148.JPG

Looking east at large hole on right wing wall.

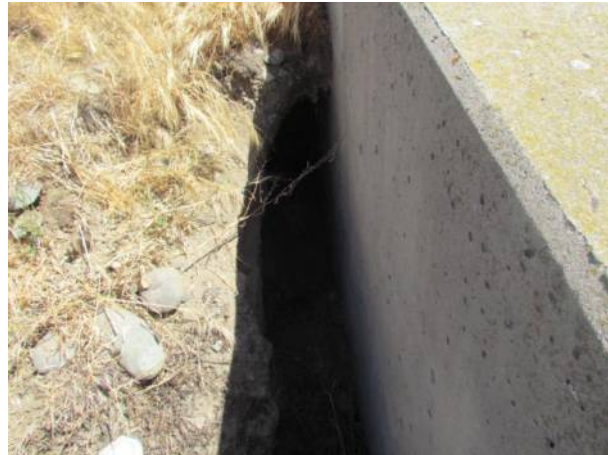
Richard\_t\_20130730\_149.JPG

Looking east at large hole next to right wing wall.

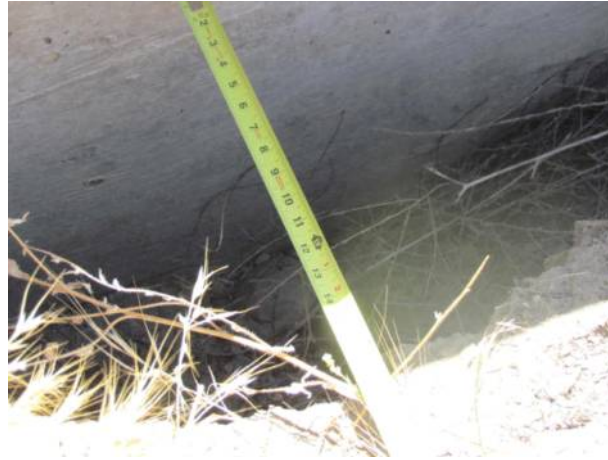
Richard\_t\_20130730\_150.JPG

Looking at hole next to right wing wall.

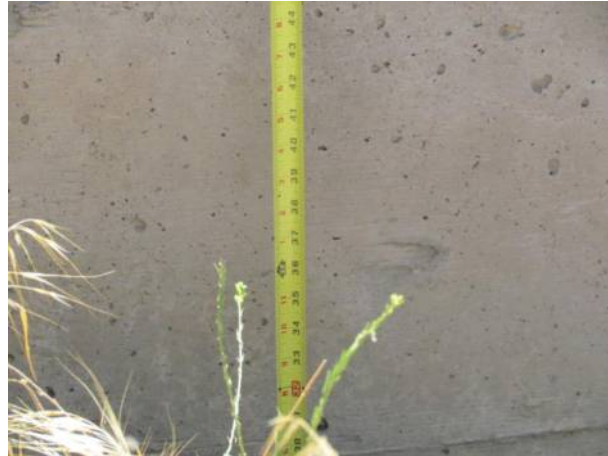
Richard\_t\_20130730\_151.JPG

Looking at depth of hole, hole is approx. 4-5 feet deep.

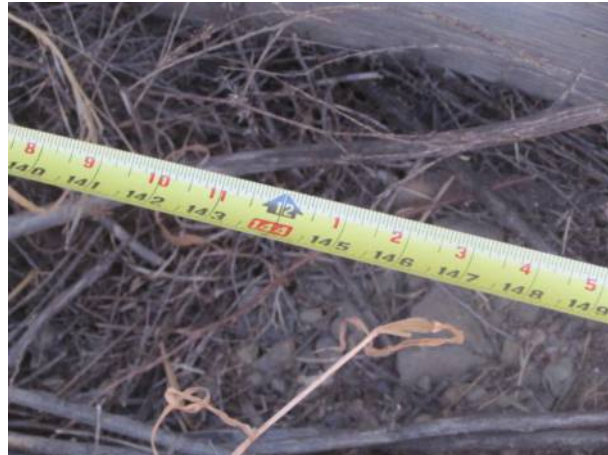
Richard\_t\_20130730\_152.JPG

Looking length of hole, hole is approx. 12 feet long.

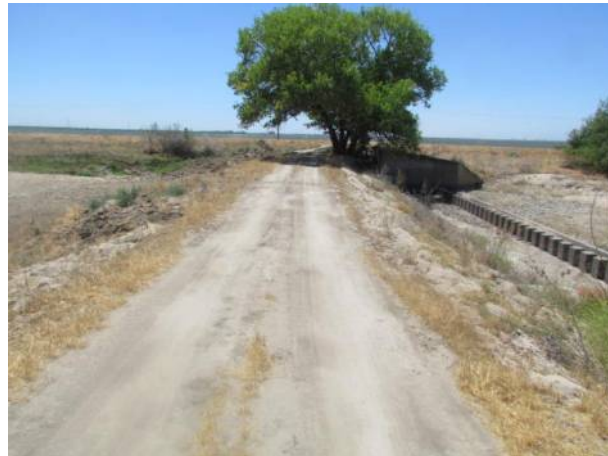
Levee Mile Report Line	6
Start Levee Mile	0.00
End Levee Mile	0.00
Location	
Category	Structures
Item	Encroachments
Looking east at sand dam on upstream side of drop structure # 4.	
richard_t_20130715_014.JPG

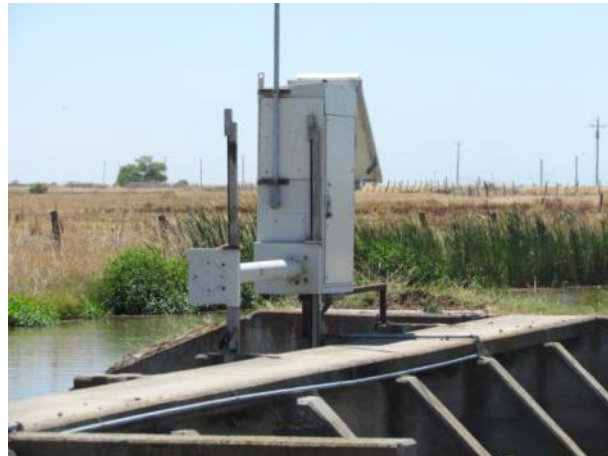
Levee Mile Report Line	6
Start Levee Mile	0.00
End Levee Mile	0.00
Location	
Category	Structures
Item	Encroachments
Looking north at electric control gate on east side of structure.	
richard_t_20130715_022.JPG

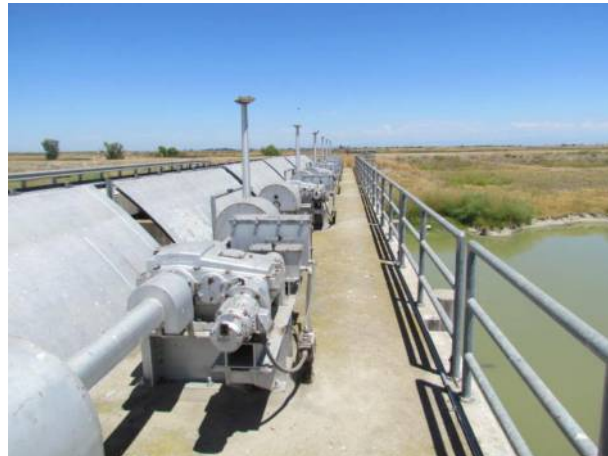
Levee Mile Report Line	13
Start Levee Mile	0.00
End Levee Mile	0.00
Location	
Category	Structures
Item	Electric Gate Operators
Looking north at several electric motors on upstream side of structure	
richard_t_20130715_031.JPG

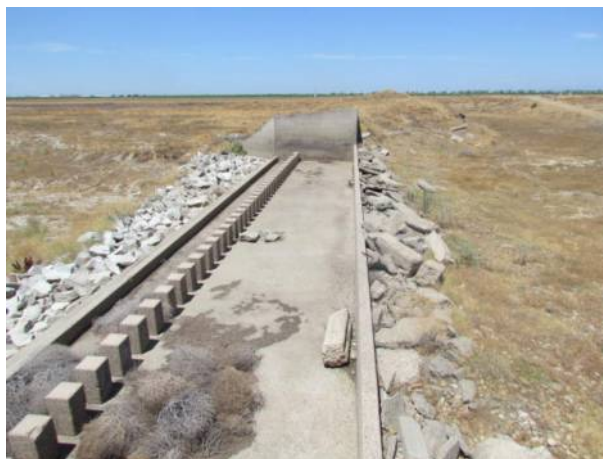
Richard\_t\_20130730\_168.JPG

Looking south at side overview of side.

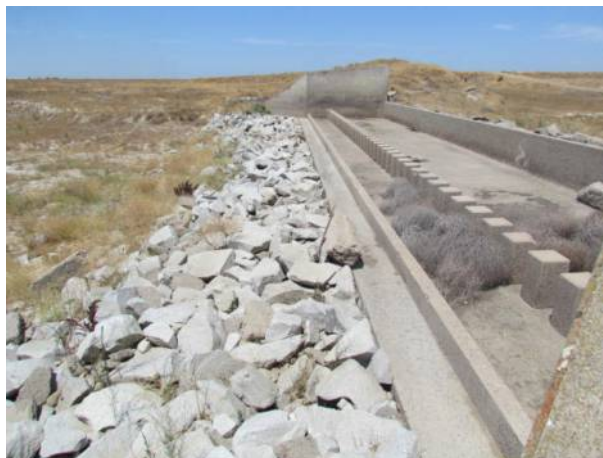
Levee Mile Report Line	5
Start Levee Mile	0.00
End Levee Mile	0.00
Location	
Category	Structures
Item	Revetments

Looking south at revement on downstream side of structure.

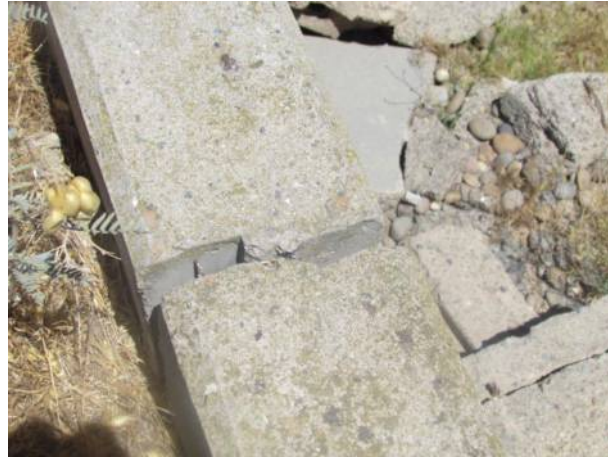
richard\_t\_20130715\_039.JPG

Looking at joint separation on left side of structure.

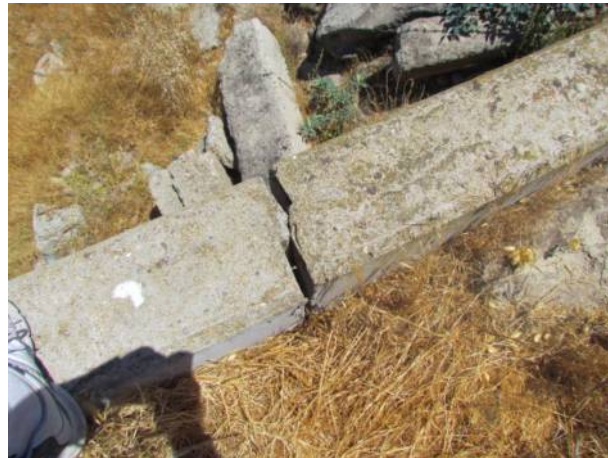
Levee Mile Report Line	22
Start Levee Mile	0.00
End Levee Mile	0.00
Location	
Category	Structures
Item	Monolith Joints

Looking at joint separation on left side of structure (2013)

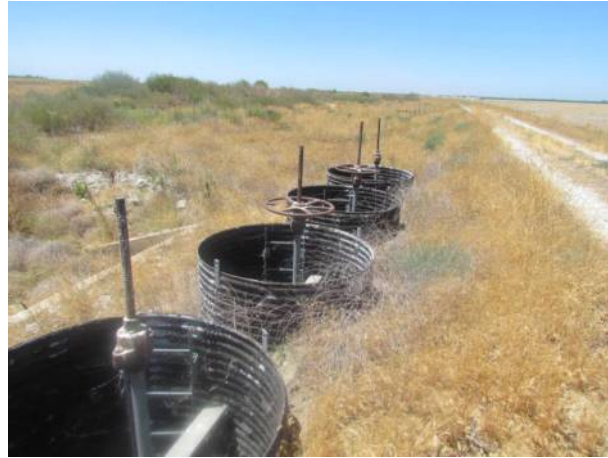
Levee Mile Report Line	1
Start Levee Mile	0.00
End Levee Mile	0.00
Location	
Category	Structures
Item	Photo Documentation
Looking west at screw gates on outlet side of structure.	
richard_t_20130715_040.JPG

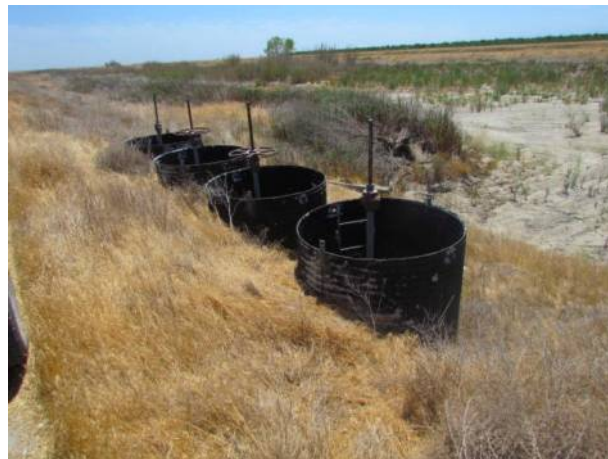
Levee Mile Report Line	1
Start Levee Mile	0.00
End Levee Mile	0.00
Location	
Category	Structures
Item	Photo Documentation
Looking southwest at control gates on downstream side of structure.	
Richard_t_20130730_162.JPG

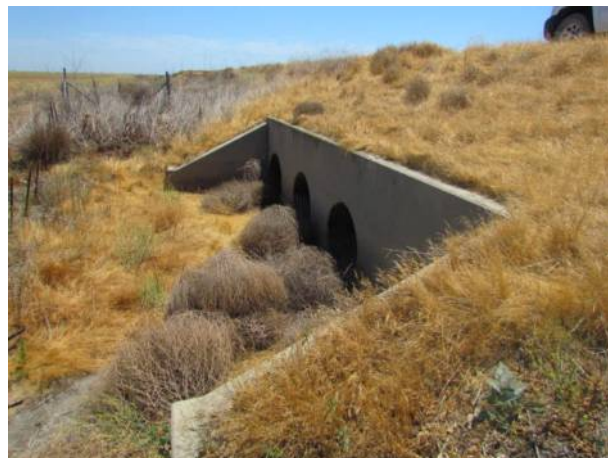
Levee Mile Report Line	1
Start Levee Mile	0.00
End Levee Mile	0.00
Location	
Category	Structures
Item	Photo Documentation
Looking southwest at inlet side of structure.	
Richard_t_20130730_164.JPG

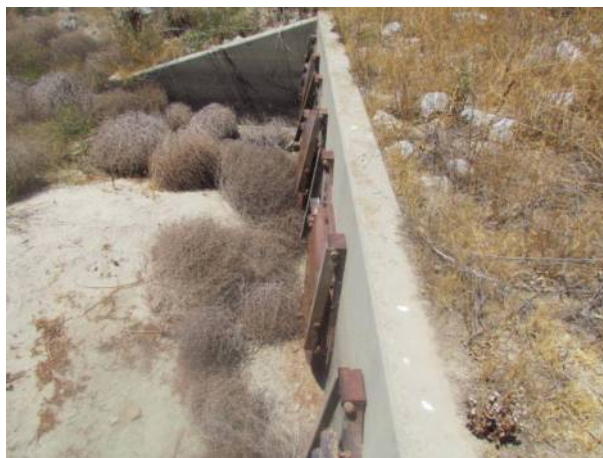
Levee Mile Report Line	11
Start Levee Mile	0.00
End Levee Mile	0.00
Location	
Category	Structures
Item	Flap Gates
Looking west at flap gates.	
richard_t_20130715_042.JPG

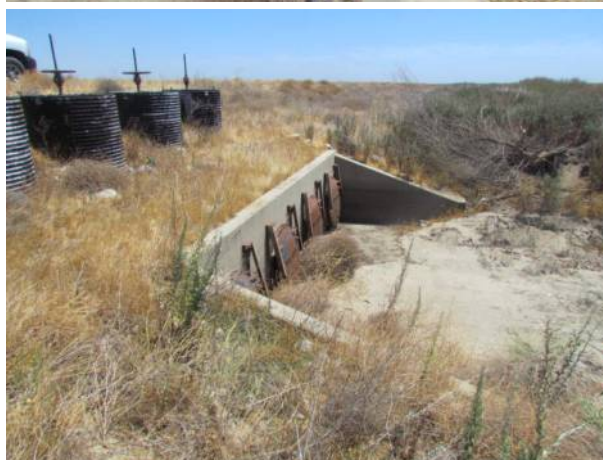
Levee Mile Report Line	11
Start Levee Mile	0.00
End Levee Mile	0.00
Location	
Category	Structures
Item	Flap Gates
Looking southeast at flap gates on downstream side of structure.	
Richard_t_20130730_163.JPG

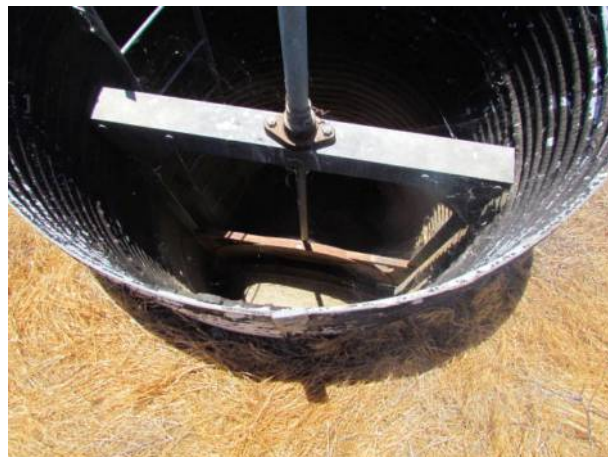
Levee Mile Report Line	14
Start Levee Mile	0.00
End Levee Mile	0.00
Location	
Category	Structures
Item	Manual Gate Operators
Looking at typical view of screw gate on outlet side of structure.	
Richard_t_20130730_165.JPG

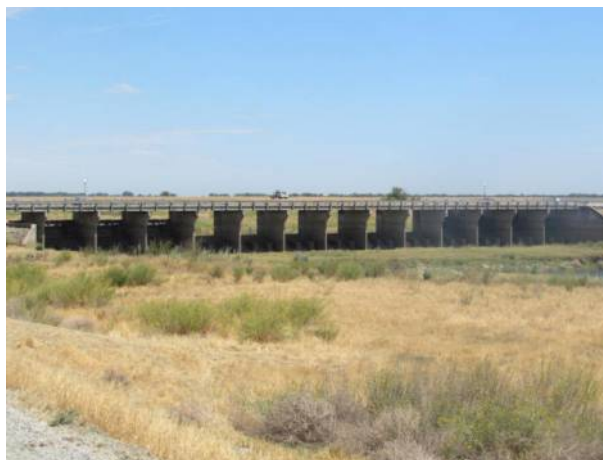
Richard\_t\_20130730\_123.JPG

Looking east at upstream side of structure.

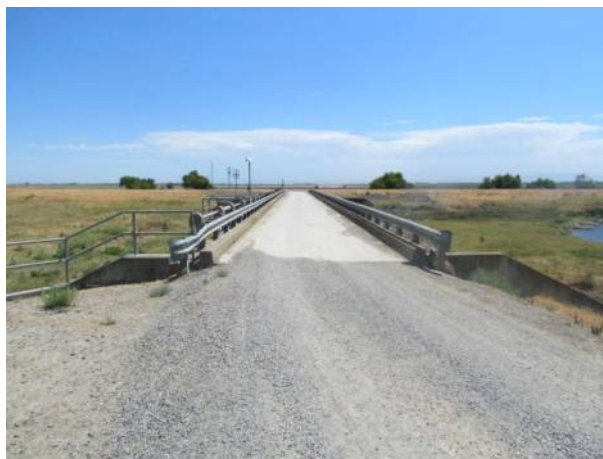
Levee Mile Report Line	1
Start Levee Mile	0.00
End Levee Mile	0.00
Location	Water Side
Category	Structures
Item	Photo Documentation

Looking south at overview of structure.

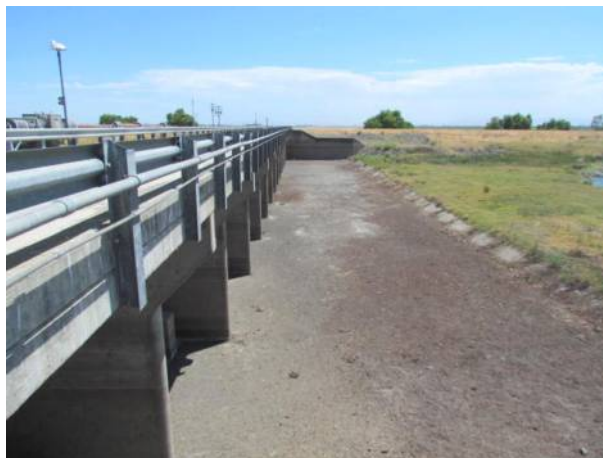
Levee Mile Report Line	1
Start Levee Mile	0.00
End Levee Mile	0.00
Location	Water Side
Category	Structures
Item	Photo Documentation

Looking south at upstream side of structure.

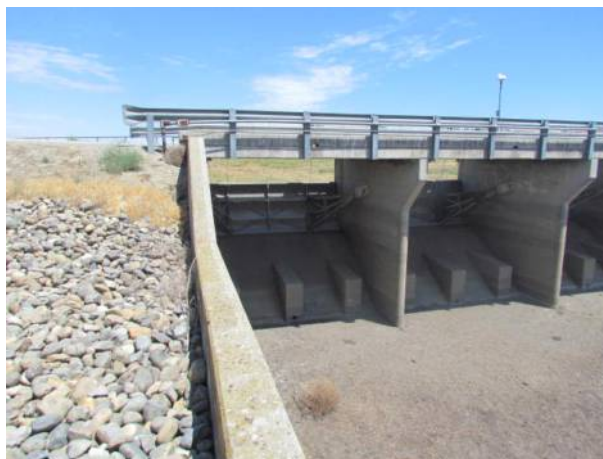
Richard\_t\_20130730\_126.JPG

Looking east at typical view of gate and bay from the upstream side of structure.

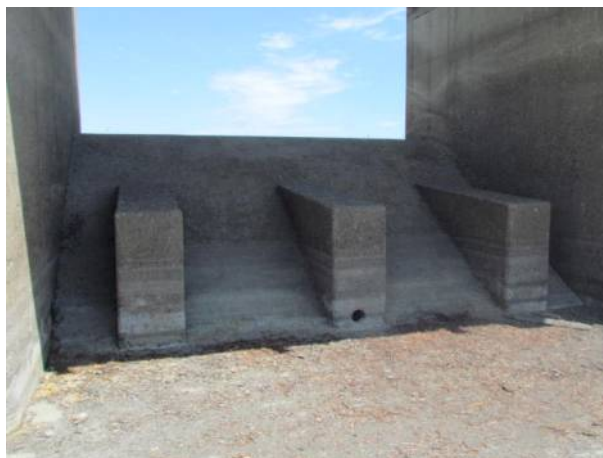
Levee Mile Report Line	1
Start Levee Mile	0.00
End Levee Mile	0.00
Location	Water Side
Category	Structures
Item	Photo Documentation

Looking east at typical view of structure bay

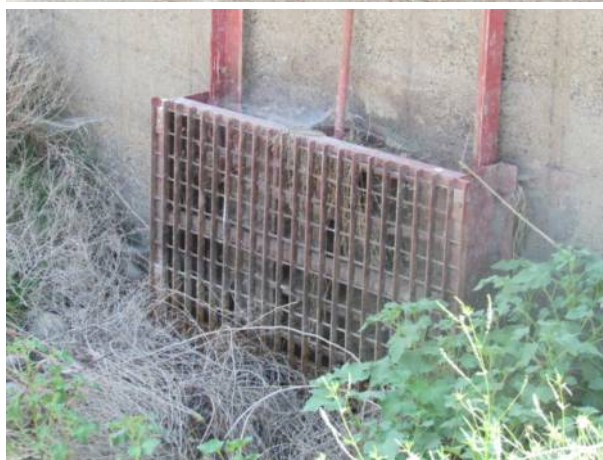
Levee Mile Report Line	10
Start Levee Mile	0.00
End Levee Mile	0.00
Location	Water Side
Category	Structures
Item	Trash Racks

Looking southwest at trash rack on downstream side of structure.

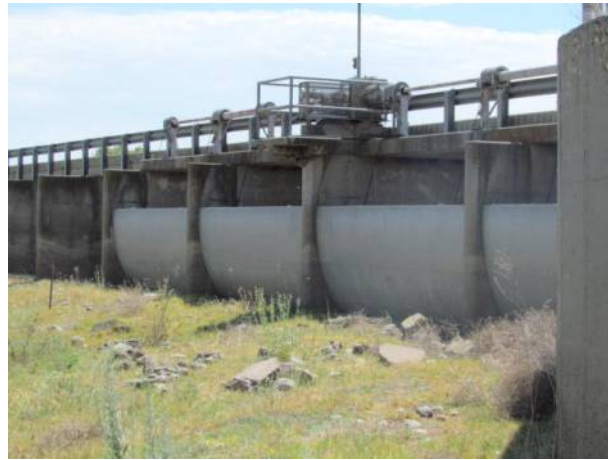
Richard\_t\_20130730\_130.JPG

Looking at gates on downstream side of structure.

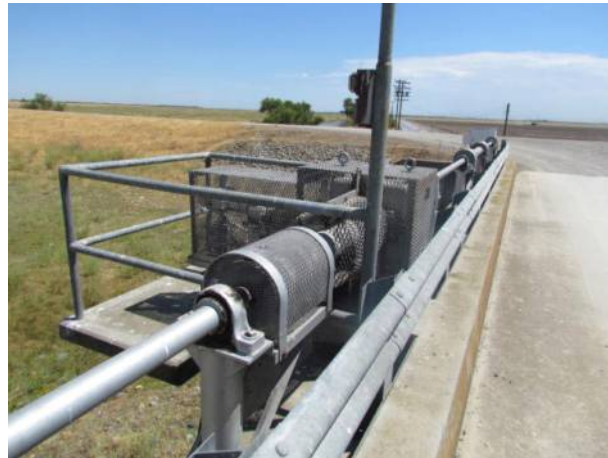
Levee Mile Report Line	13
Start Levee Mile	0.00
End Levee Mile	0.00
Location	Water Side
Category	Structures
Item	Electric Gate Operators

Looking south at typical view of electric gate operators on downstream side of structure.

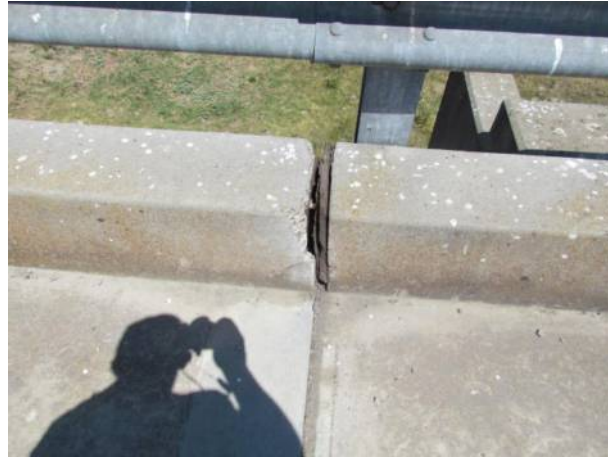
Richard\_t\_20130730\_132.JPG

21	0.00	0.00	Structures	Other Metallic Items	WS	A	Inspector Comments: No visible corrosion.	37.201538 ° -120.694813 °	37.201538 ° -120.694813 °	21
22	0.00	0.00	Structures	Monolith Joints	WS	A	Inspector Comments: Minor joint cracking on curve on south end of upstream side of structure.	37.201538 ° -120.694813 °	37.201538 ° -120.694813 °	22 Y
23	0.00	0.00	Structures	Safety	WS	A	Inspector Comments: No safety hazards visible.	37.201538 ° -120.694813 °	37.201538 ° -120.694813 °	23
24	0.00	0.00	Structures	Operation & Maintenance Manual	WS	A	Inspector Comments: The manual is on file in the office.	37.201538 ° -120.694813 °	37.201538 ° -120.694813 °	24

Looking east at minor crack on joint at top of structure on the downstream side of structure.

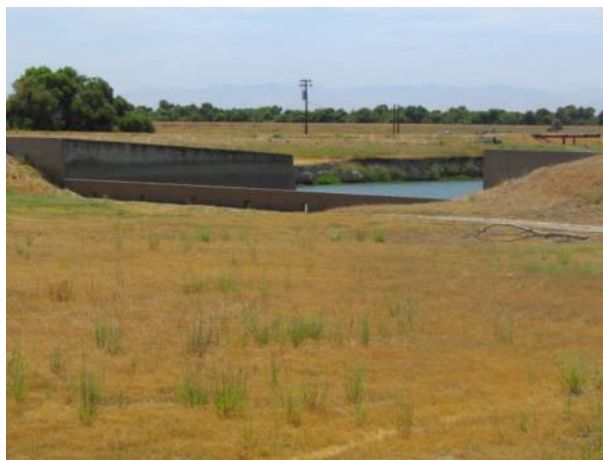
Richard\_t\_20130730\_118.JPG

Looking west at upstream side of structure.

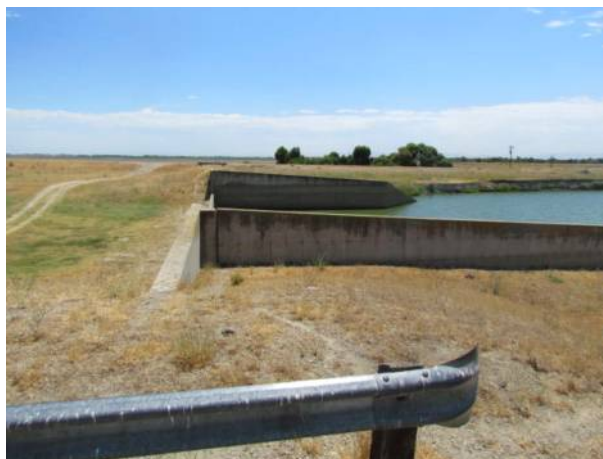
Levee Mile Report Line	1
Start Levee Mile	0.00
End Levee Mile	0.00
Location	
Category	Structures
Item	Photo Documentation

Looking south at overview of structure.

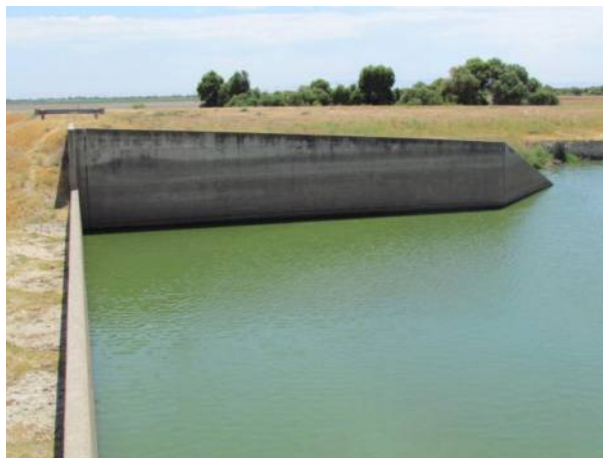
Levee Mile Report Line	1
Start Levee Mile	0.00
End Levee Mile	0.00
Location	
Category	Structures
Item	Photo Documentation

Looking south at left wing wall.

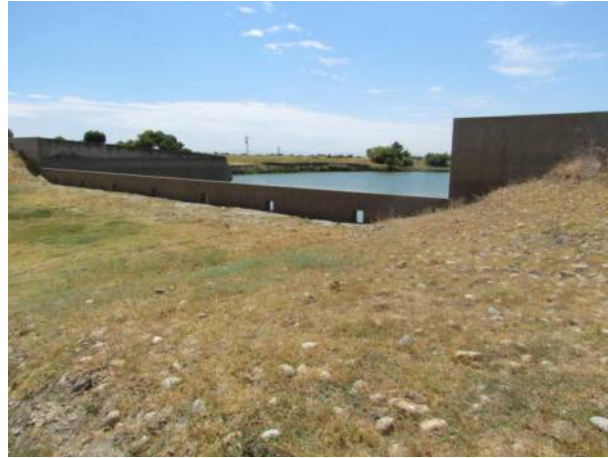
Levee Mile Report Line	1
Start Levee Mile	0.00
End Levee Mile	0.00
Location	
Category	Structures
Item	Photo Documentation
Looking at upstream side of structure.	
Richard_t_20130730_121.JPG

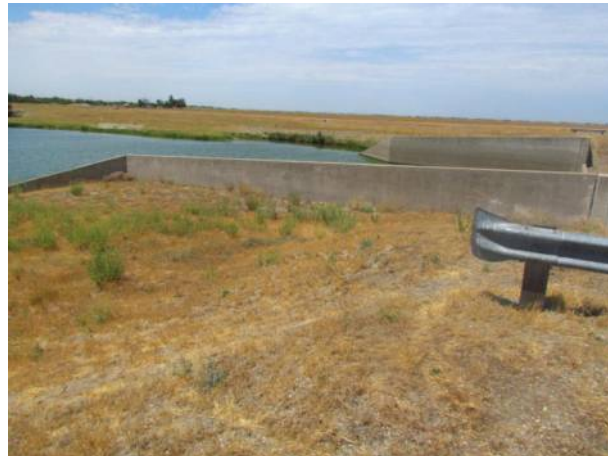
Levee Mile Report Line	1
Start Levee Mile	0.00
End Levee Mile	0.00
Location	
Category	Structures
Item	Photo Documentation
Looking south at right wing wall.	
Richard_t_20130730_122.JPG

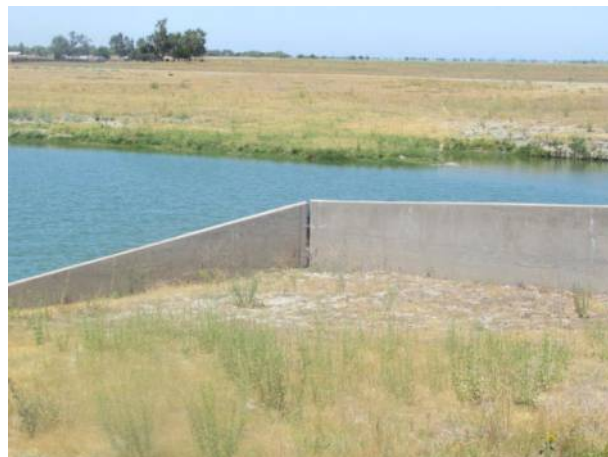
22	0.00	0.00	Structures	Monolith Joints		A	Inspector Comments: Some movement at left wing wall joints.	37.201227 ° -120.755223 °	37.201227 ° -120.755223 °	22 Y
23	0.00	0.00	Structures	Safety		A	Inspector Comments: No visible safety hazards.	37.201227 ° -120.755223 °	37.201227 ° -120.755223 °	23
24	0.00	0.00	Structures	Operation & Maintenance Manual		A	Inspector Comments: The manual is on file in the office.	37.201227 ° -120.755223 °	37.201227 ° -120.755223 °	24

Levee Mile Report Line	22
Start Levee Mile	0.00
End Levee Mile	0.00
Location	
Category	Structures
Item	Monolith Joints
Looking north at joint on left wing wall on downstream of structure.	
richard_t_20130715_053.JPG

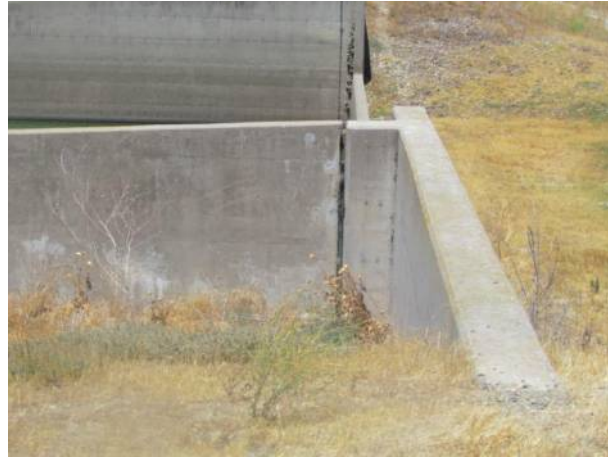
richard\_t\_20130715\_054.JPG

Looking at joint on left wing wall.

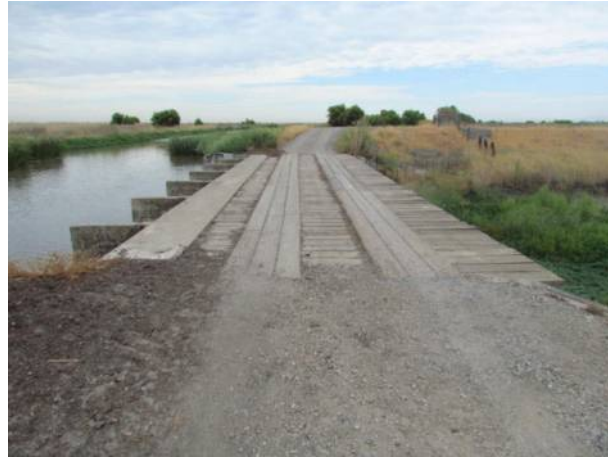
richard\_t\_20130729\_101.JPG

Looking south at overview of structure.

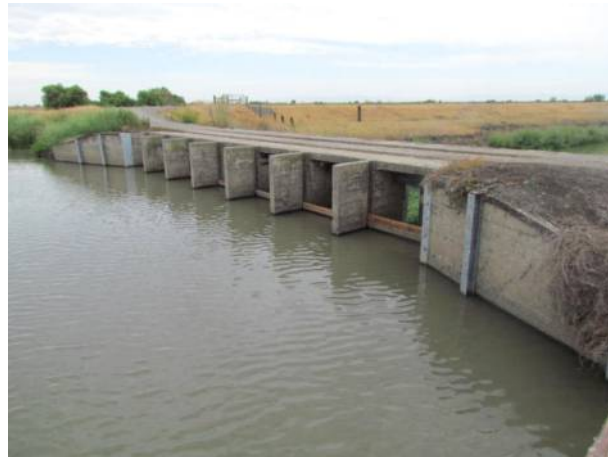
Levee Mile Report Line	1
Start Levee Mile	0.00
End Levee Mile	0.00
Location	
Category	Structures
Item	Photo Documentation

Looking at upstream side of structure.

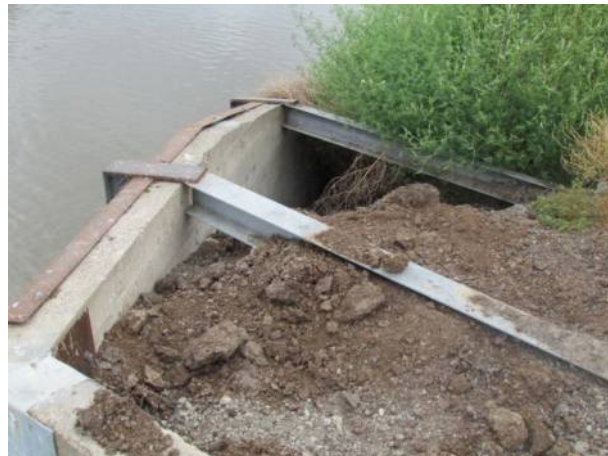
Levee Mile Report Line	4
Start Levee Mile	0.00
End Levee Mile	0.00
Location	
Category	Structures
Item	Erosion / Bank Caving

Looking at new braces on wing wall and more fill material needed.

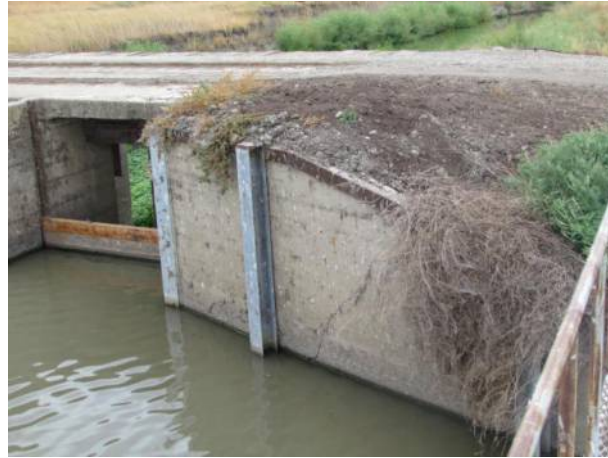
Levee Mile Report Line	15
Start Levee Mile	0.00
End Levee Mile	0.00
Location	
Category	Structures
Item	Concrete Surfaces
Looking at right wing wall on upstream side of structure. Minor crack on wall.	
richard_t_20130729_103.JPG

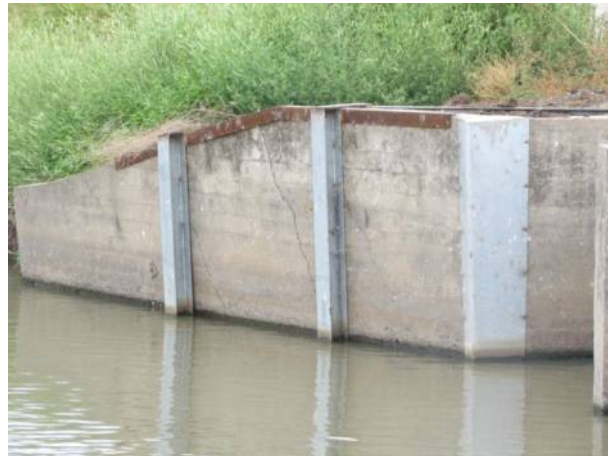
Levee Mile Report Line	15
Start Levee Mile	0.00
End Levee Mile	0.00
Location	
Category	Structures
Item	Concrete Surfaces
Looking at left wing wall on upstream side of structure.	
richard_t_20130729_104.JPG

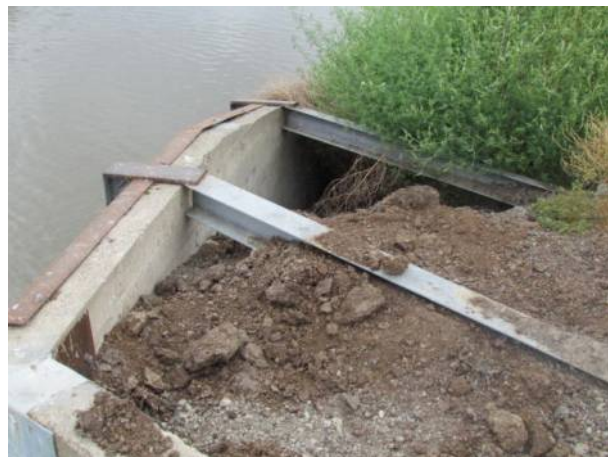
Levee Mile Report Line	15
Start Levee Mile	0.00
End Levee Mile	0.00
Location	
Category	Structures
Item	Concrete Surfaces
Looking southeast at braces and large hole on left wing wall on upstream side of structure.	
richard_t_20130729_105.JPG

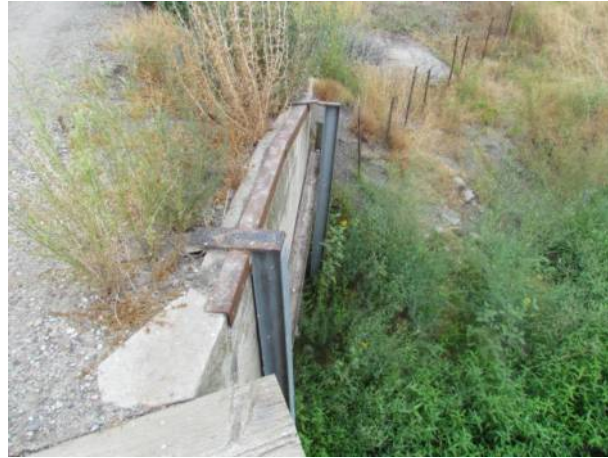
Levee Mile Report Line	15
Start Levee Mile	0.00
End Levee Mile	0.00
Location	
Category	Structures
Item	Concrete Surfaces
Looking at left wing wall on downstream side of structure.	
richard_t_20130729_106.JPG

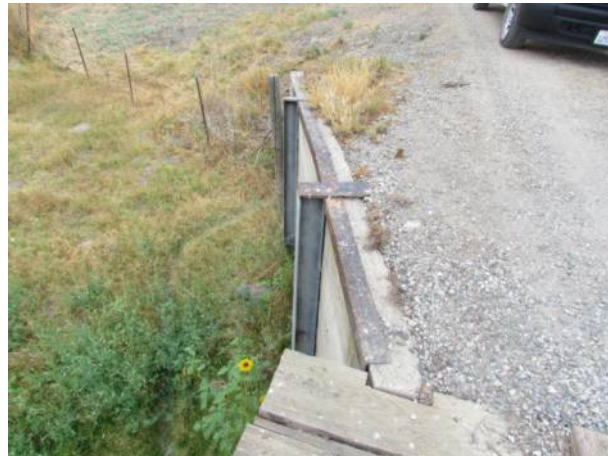
Levee Mile Report Line	15
Start Levee Mile	0.00
End Levee Mile	0.00
Location	
Category	Structures
Item	Concrete Surfaces
Looking at right wing wall on upstream side of structure.	
richard_t_20130729_107.JPG

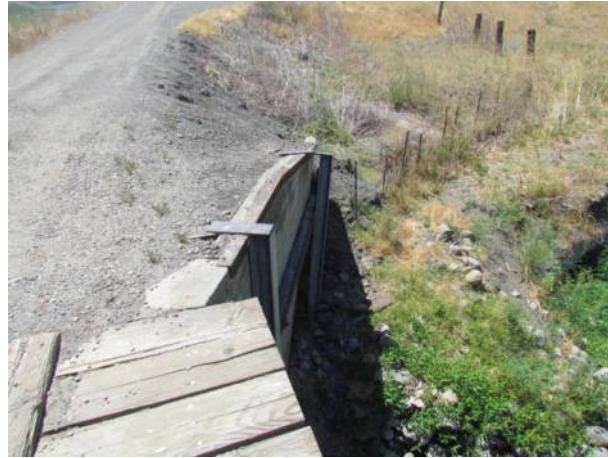
richard\_t\_20130715\_063.JPG

Looking west at brace on right wing wall on downstream side of structure. Summer 2012

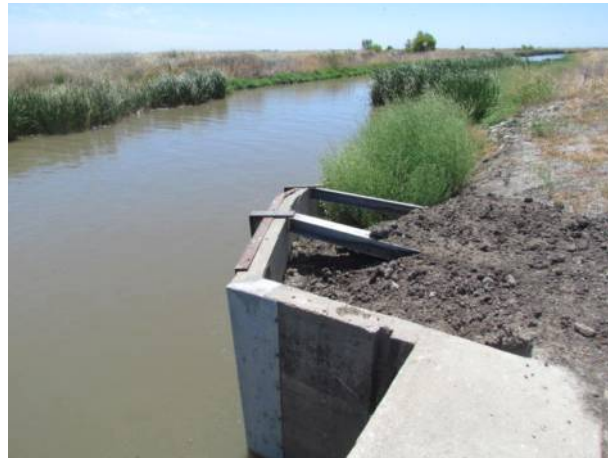
Levee Mile Report Line	22
Start Levee Mile	0.00
End Levee Mile	0.00
Location	
Category	Structures
Item	Monolith Joints

21	0.00	0.00	Structures	Other Metallic Items		N	Inspector Comments: Item does not exist on this structure.	37.219788 ° -120.698058 °	37.219788 ° -120.698058 °	21
22	0.00	0.00	Structures	Monolith Joints		M	Inspector Comments: Left & right wing walls joint has been repaired, but still unstable.	37.219788 ° -120.698058 °	37.219788 ° -120.698058 °	22 Y
23	0.00	0.00	Structures	Safety		A	Inspector Comments: No visible hazards.	37.219788 ° -120.698058 °	37.219788 ° -120.698058 °	23
24	0.00	0.00	Structures	Operation & Maintenance Manual		A	Inspector Comments: The manual is on file in the office.	37.219788 ° -120.698058 °	37.219788 ° -120.698058 °	24

Looking at repaired left wing wall on upstream side of structure. Summer 2012

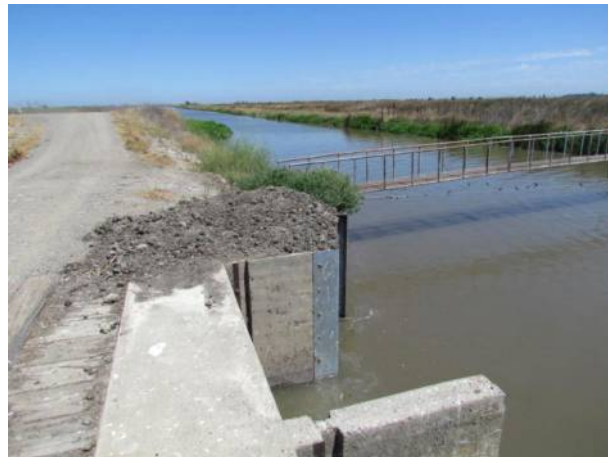
Levee Mile Report Line	22
Start Levee Mile	0.00
End Levee Mile	0.00
Location	
Category	Structures
Item	Monolith Joints

Looking at repaired right wing wall on upstream side of structure.

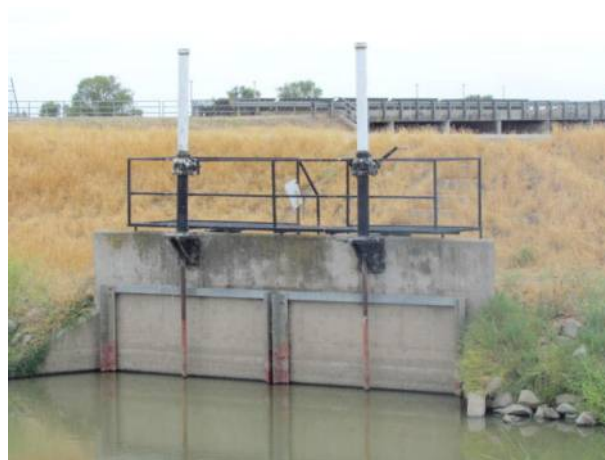
richard\_t\_20130729\_108.JPG

Looking west at upstream side of structure.

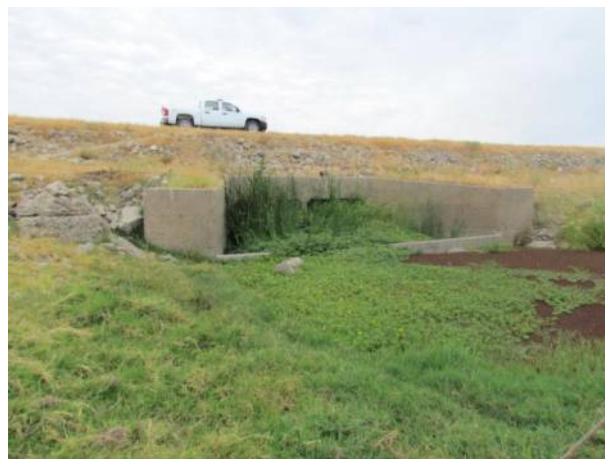
richard\_t\_20130729\_109.JPG

Looking at outlet side of structure.

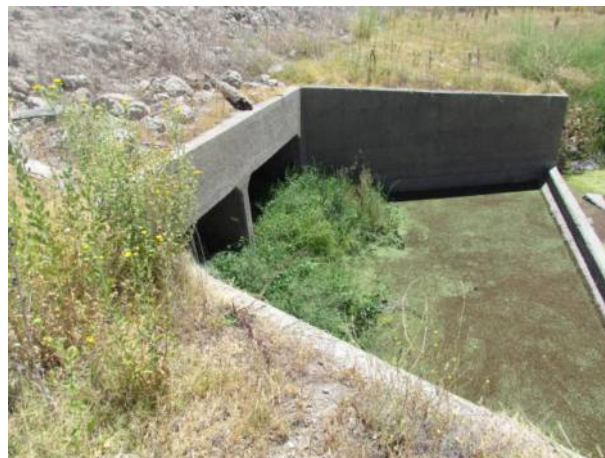
richard\_t\_20130715\_068.JPG

Looking southwest at outlet of structure. (Summer 2012)

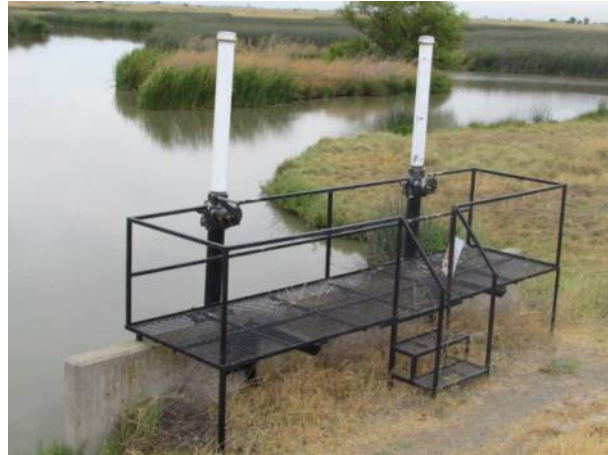
richard\_t\_20130729\_111.JPG

Looking east at manual gate on upstream side of structure.

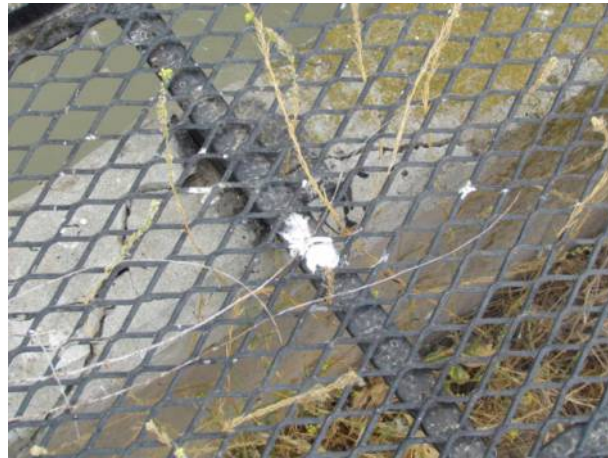
richard\_t\_20130729\_110.JPG

Looking at cracking on headwall.

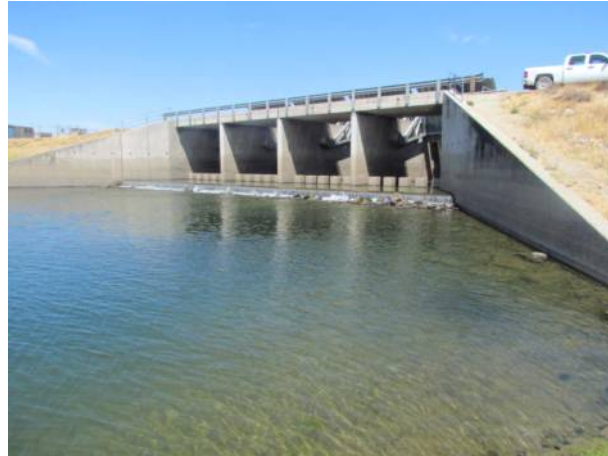
Levee Mile Report Line	1
Start Levee Mile	0.00
End Levee Mile	0.00
Location	
Category	Structures
Item	Photo Documentation
Looking southeast at overview of downstream side of the SJRS.	
richard_t_20130731_174.JPG

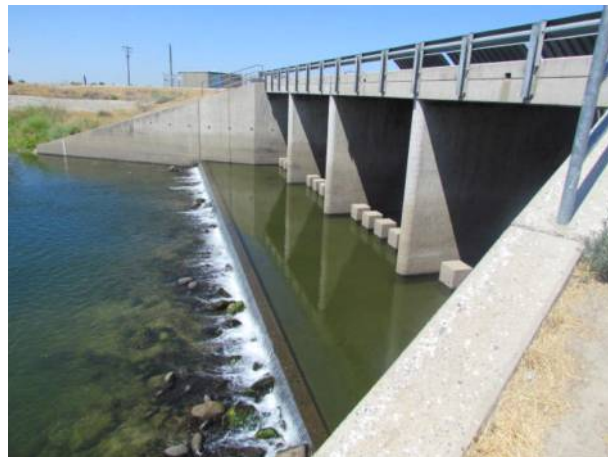
Levee Mile Report Line	1
Start Levee Mile	0.00
End Levee Mile	0.00
Location	
Category	Structures
Item	Photo Documentation
Looking north at overview of downstream side of SJRCS.	
richard_t_20130731_175.JPG

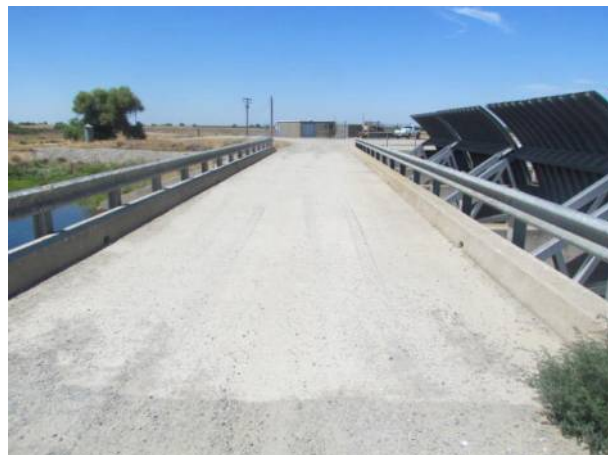
Levee Mile Report Line	1
Start Levee Mile	0.00
End Levee Mile	0.00
Location	
Category	Structures
Item	Photo Documentation
Looking north at top of SJRCS.	
richard_t_20130731_176.JPG

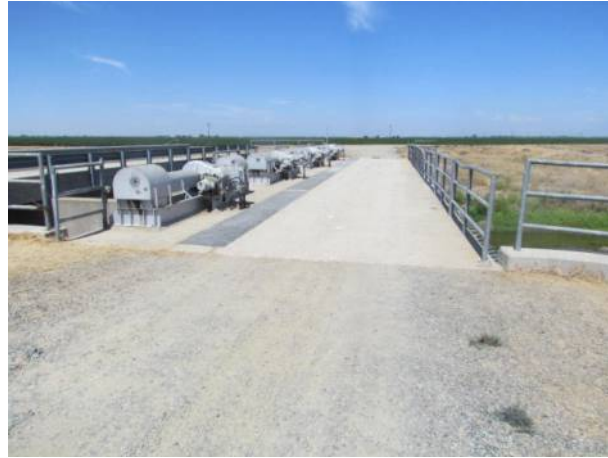
richard\_t\_20130731\_180.JPG

Looking east at overview of the top of the CCBCS.

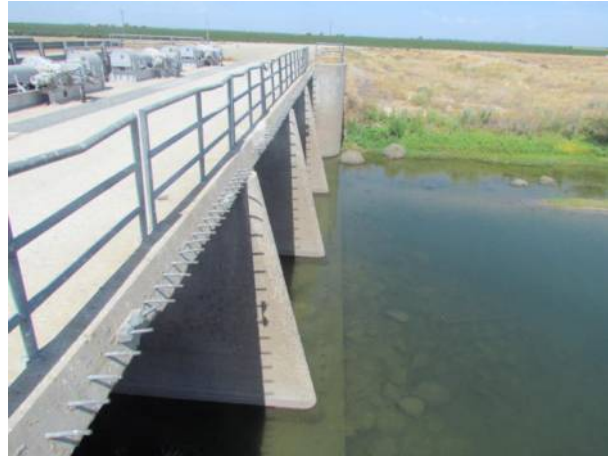
richard\_t\_20130731\_181.JPG

Looking at overview of upstream side of the CCBCS.

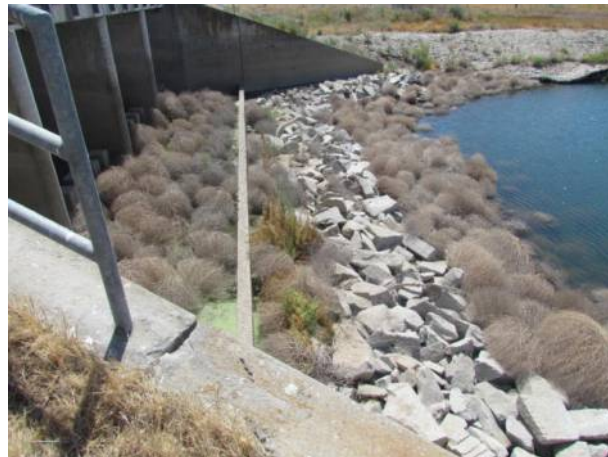
richard\_t\_20130731\_182.JPG

Looking north at overview of the downstream side of CCBPCS.

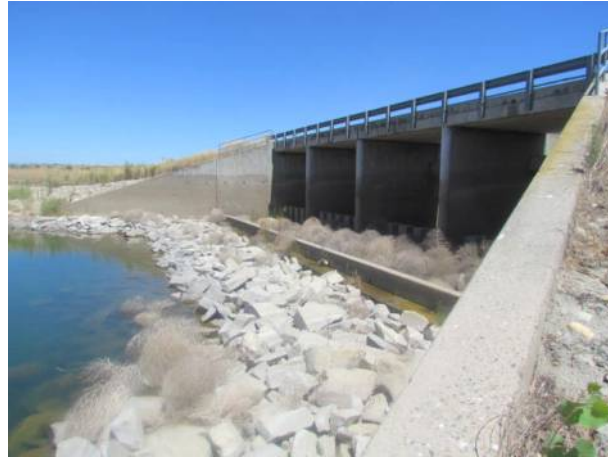
Levee Mile Report Line	5
Start Levee Mile	0.00
End Levee Mile	0.00
Location	
Category	Structures
Item	Revetments
Looking southeast at revetment on downstream side of Chowchilla Control Structure.	
richard_t_20130715_073.JPG

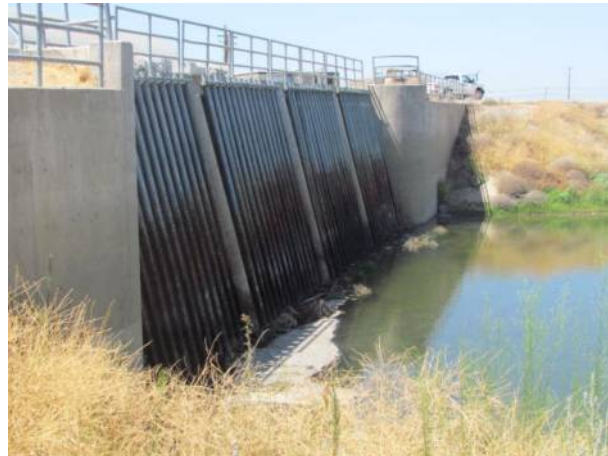
Levee Mile Report Line	7
Start Levee Mile	0.00
End Levee Mile	0.00
Location	
Category	Structures
Item	Culverts: Inlets / Outlets
Looking north at overview of upstream side of SJRCS.	
richard_t_20130731_179.JPG

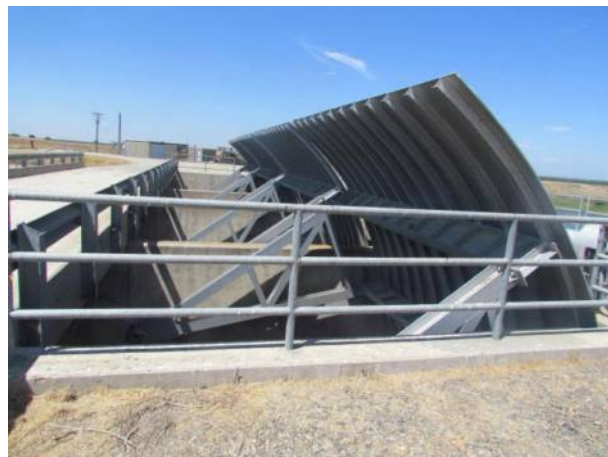
Levee Mile Report Line	12
Start Levee Mile	0.00
End Levee Mile	0.00
Location	
Category	Structures
Item	Sluice/Slide Gates
Looking north at slide gates on the SJRCS.	
richard_t_20130731_177.JPG

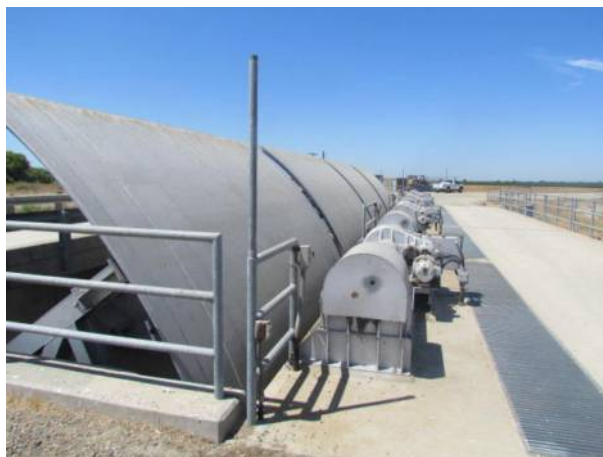
Levee Mile Report Line	12
Start Levee Mile	0.00
End Levee Mile	0.00
Location	
Category	Structures
Item	Sluice/Slide Gates
Looking southwest at slide gates on SJRCS.	
richard_t_20130731_178.JPG

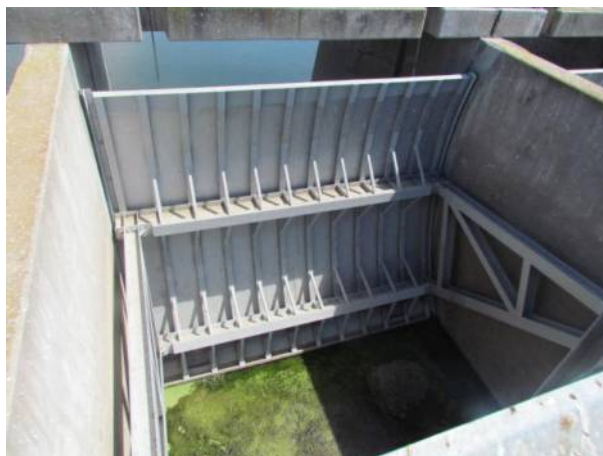
Levee Mile Report Line	12
Start Levee Mile	0.00
End Levee Mile	0.00
Location	
Category	Structures
Item	Sluice/Slide Gates
Looking northwest at typical view of the slide gate on the CCBPCS.	
richard_t_20130731_183.JPG

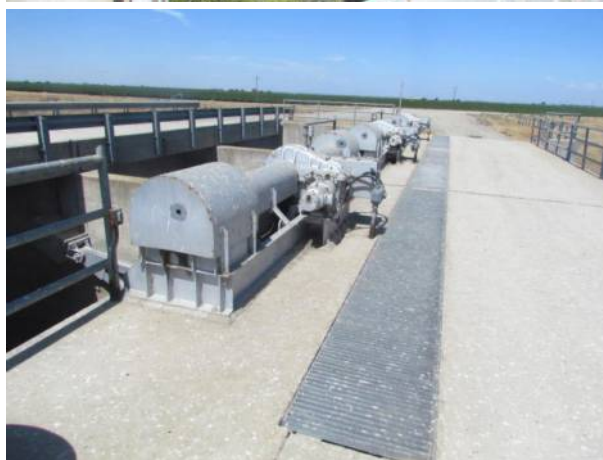
Levee Mile Report Line	13
Start Levee Mile	0.00
End Levee Mile	0.00
Location	
Category	Structures
Item	Electric Gate Operators
Looking east at typical view of gate operators on the CCBPCS. (2013)	
richard_t_20130731_185.JPG

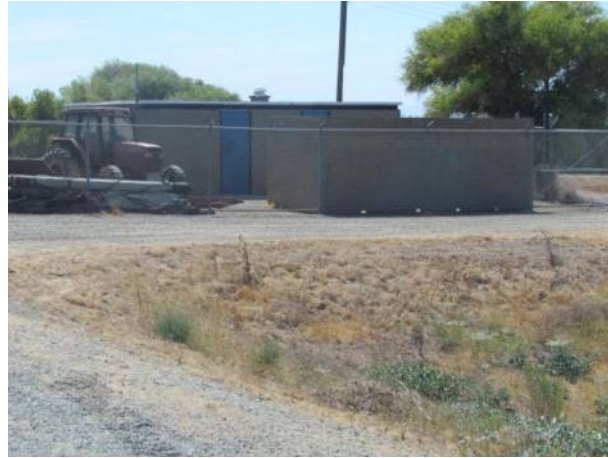
Levee Mile Report Line	18
Start Levee Mile	0.00
End Levee Mile	0.00
Location	
Category	Structures
Item	Security Fencing
Looking north at utility shed and security fencing around structure.	
richard_t_20130731_184.JPG

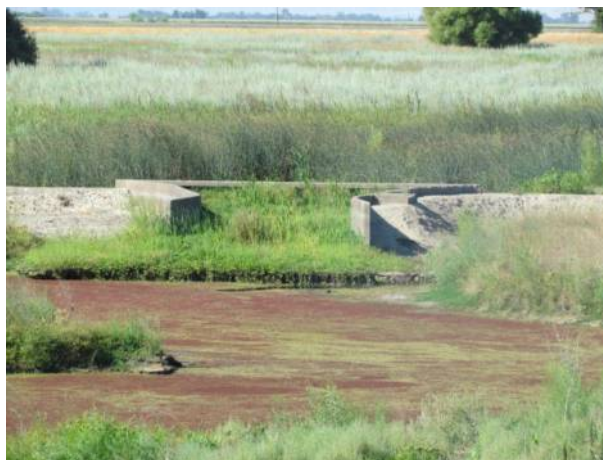
Levee Mile Report Line	1
Start Levee Mile	0.00
End Levee Mile	0.00
Location	
Category	Structures
Item	Photo Documentation
Looking east at downstream side of structure.	
Richard_t_20130730_133.JPG

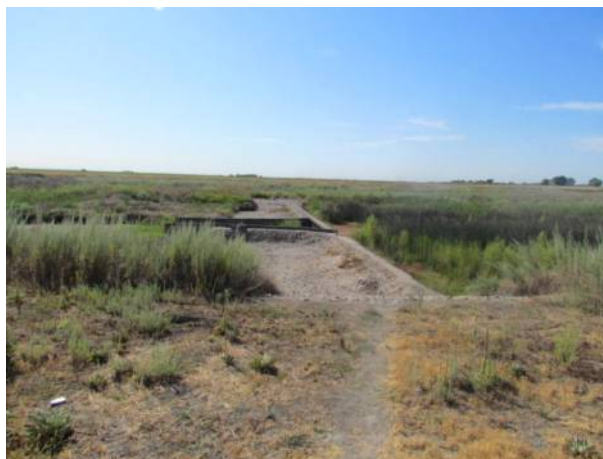
Levee Mile Report Line	1
Start Levee Mile	0.00
End Levee Mile	0.00
Location	
Category	Structures
Item	Photo Documentation
Looking south at overview of structure.	
Richard_t_20130730_134.JPG

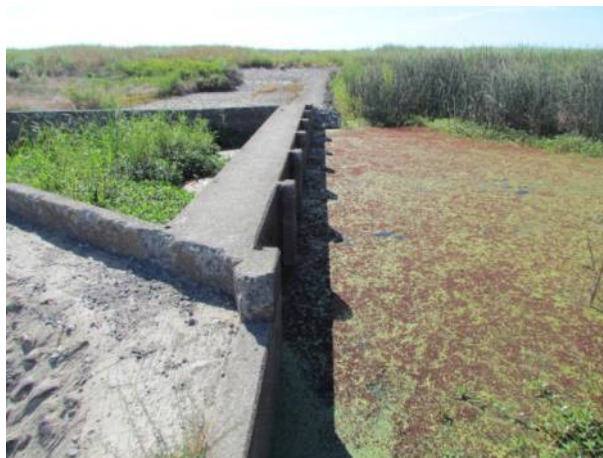
Levee Mile Report Line	1
Start Levee Mile	0.00
End Levee Mile	0.00
Location	
Category	Structures
Item	Photo Documentation
Looking south at upstream side of structure.	
Richard_t_20130730_135.JPG

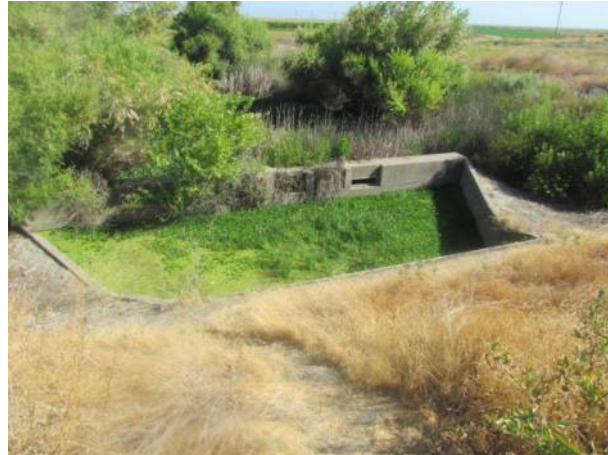
Levee Mile Report Line	7
Start Levee Mile	0.00
End Levee Mile	0.00
Location	
Category	Structures
Item	Culverts: Inlets / Outlets
Looking west at inlet of Sand Slough structure.	
richard_t_20130715_083.JPG
